**PROJECT MEMORANDUM  
CALIFORNIA VALLEY SOLAR RANCH PROJECT**

**To:** John McKenzie, San Luis Obispo County  
**From:** Vida Strong, Aspen Project Manager  
**Date:** December 13, 2011  
**Subject:** Weekly Report #13: November 27, 2011 – December 3, 2011

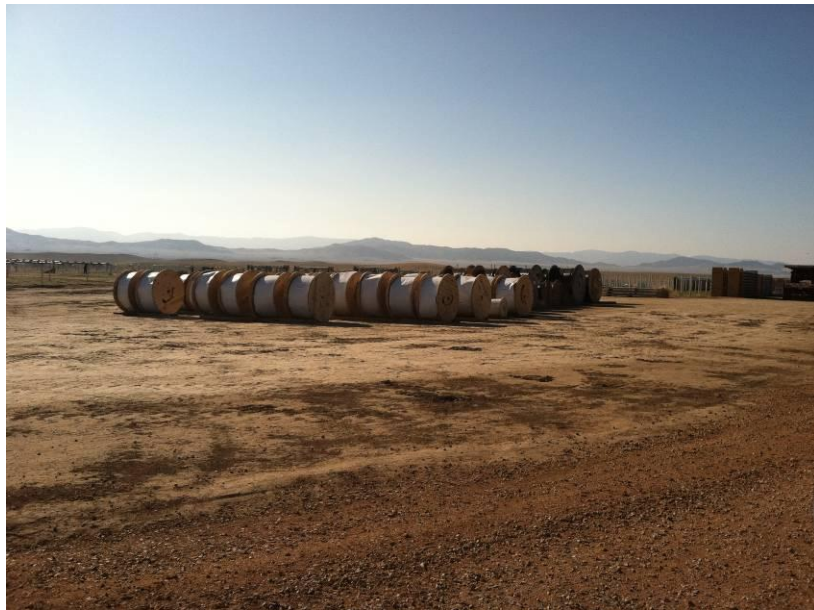
Array #1: Arriving materials continued to be shipped-to and stored-in the Array #1 area, including large spools of electrical wiring (see Figure 1). Placement of the supporting posts for the solar panels continued during the subject week. Bundles of piles for the supporting posts remain within Array #1 although the number has diminished from previous weeks as Array #1 nears completion of the pile driving phase. Welding of mounts onto installed posts continued during the subject week. Moving components were attached to these mounts within some of Array #1 (see Figure 2). None of the Array #1 activities are within designated noise sensitive areas.

**Figure 1:** Spools of electrical cables and other equipment continue to be stored in the Array #1 area. Photograph facing southward.

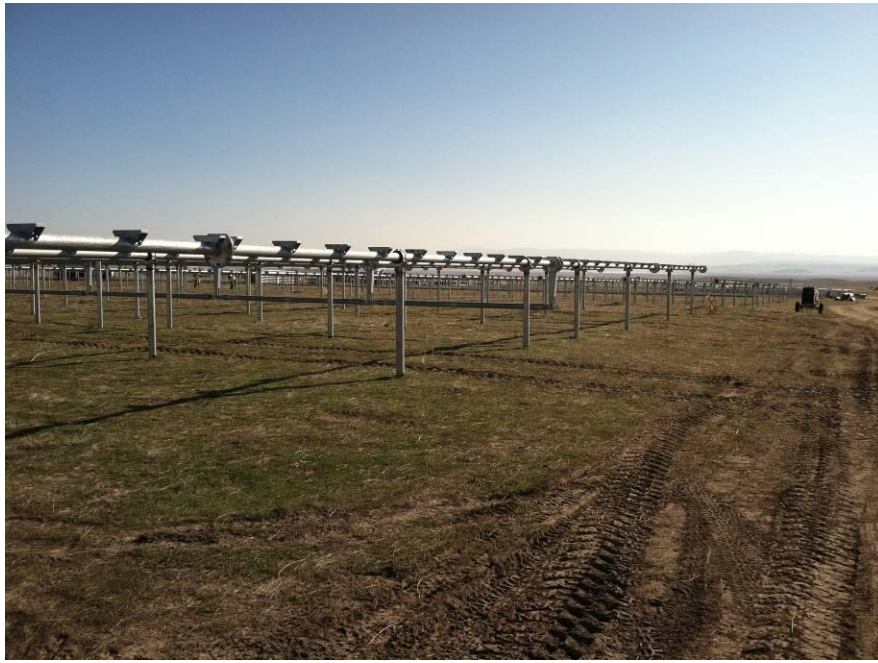
**Figure 2:** Moveable components have been installed on some of the Array #1 posts. Photograph facing south-eastward.

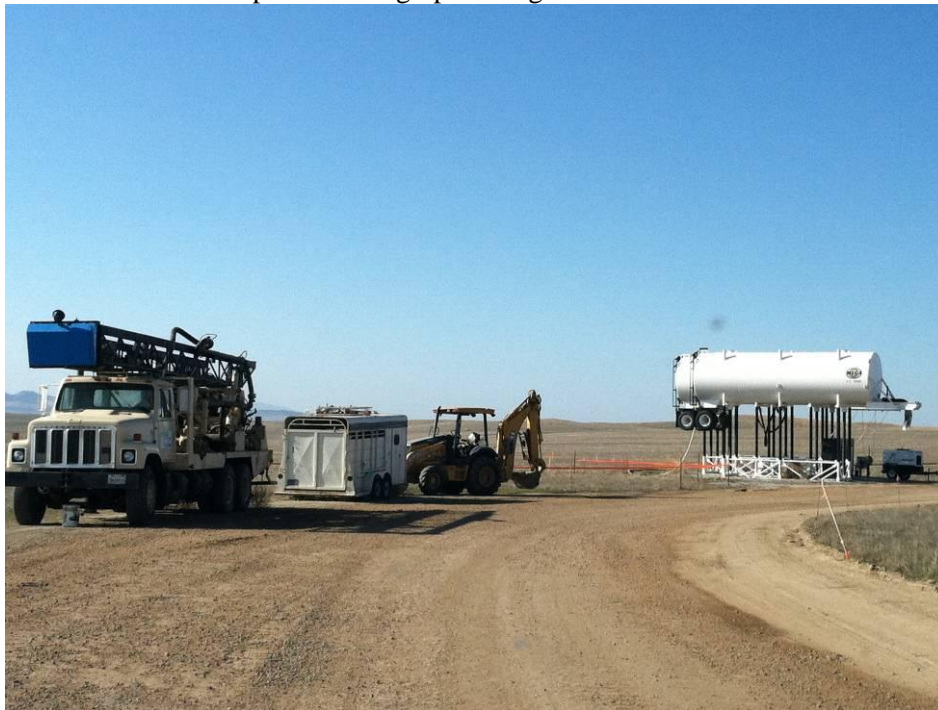
Existing Water Well 2008-325: Existing production well 2008-325 was temporarily deactivated during the subject week, as drilling crews replaced the existing well pump to increase production capacity (see Figure 3).

**Figure 3:** The original water well is receiving some upgrades to increase water production. Photograph facing westward

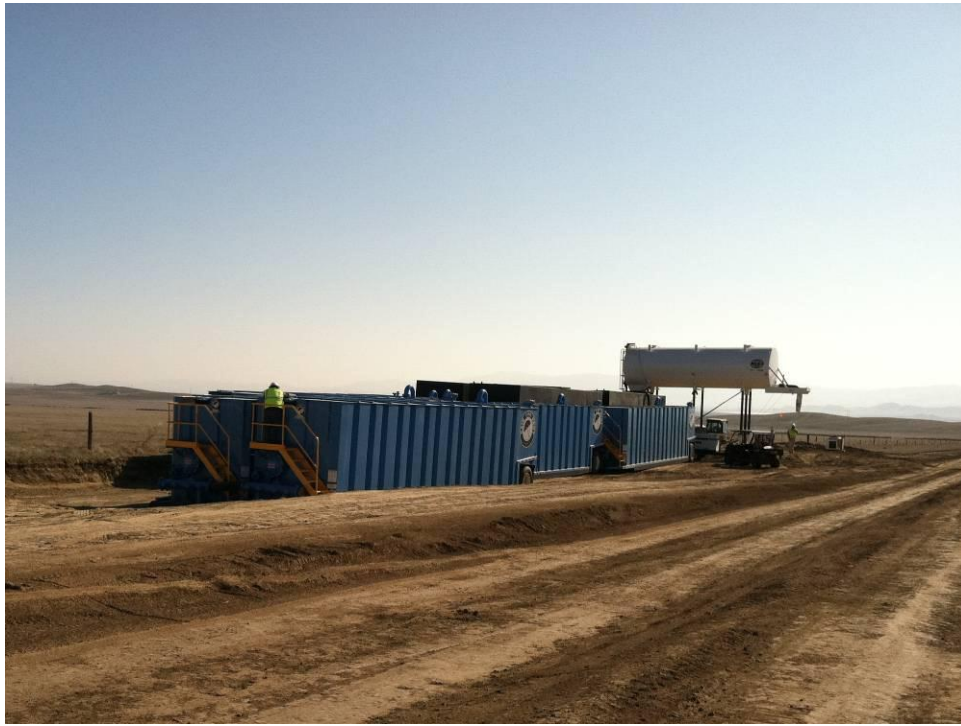
New Water Well: Production well #2 continued producing water which was used for construction during the subject week. Additional storage tanks arrived at the second production well during subject week (see Figure 4).

**Figure 4:** The second production well received some additional water storage tanks to help increase the available water supply. Photograph facing southward.

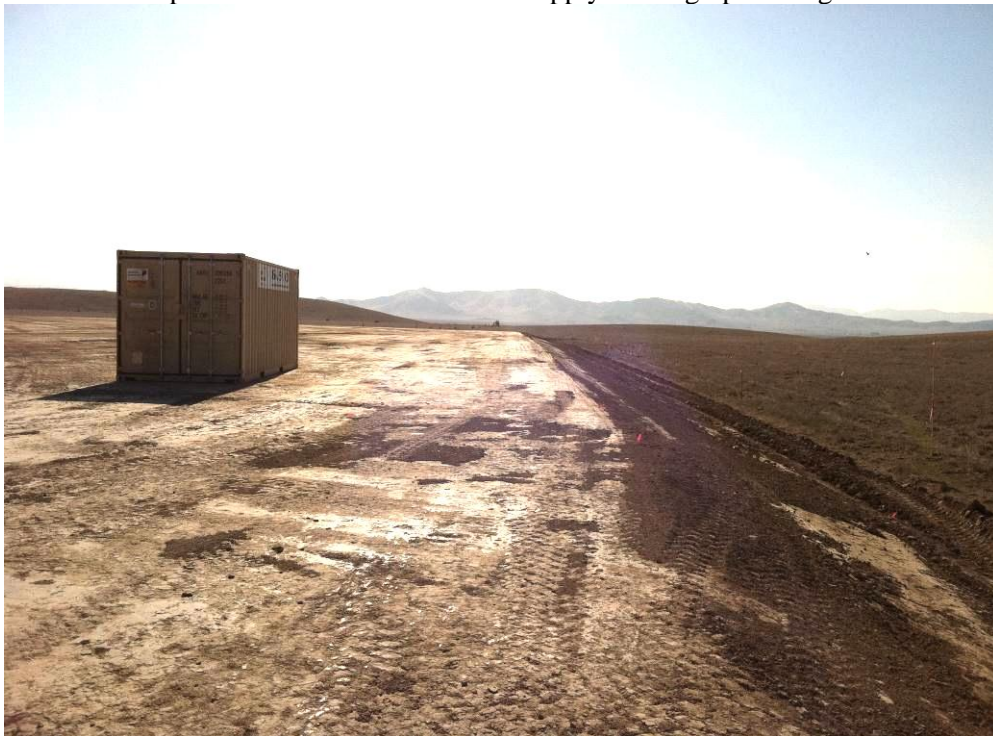
Substation: The graded site for the Project Substation, including the stockpiled topsoil and seed bank, has been lined with erosion control materials. Grading and compaction work of the substation site was completed during the subject week (see Figure 5).

**Figure 5:** Compaction work at the Substation is essentially complete. Photograph facing southward.

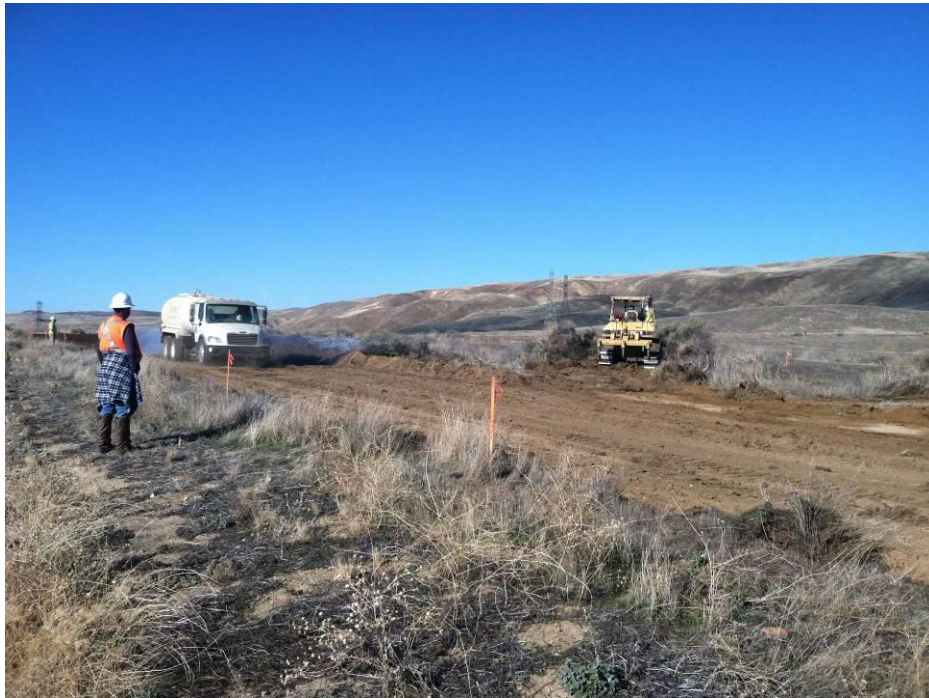
Phase 1B grading operations began during the subject week (see Figure 6). A vehicle wash station is in the process of being assembled at the Phase 1 B entrance. One scraper was relocated from the Phase 1A O&M area to the Phase 1B area.

**Figure 6:** Grading work started in the Phase 1B area. Photograph facing northward.

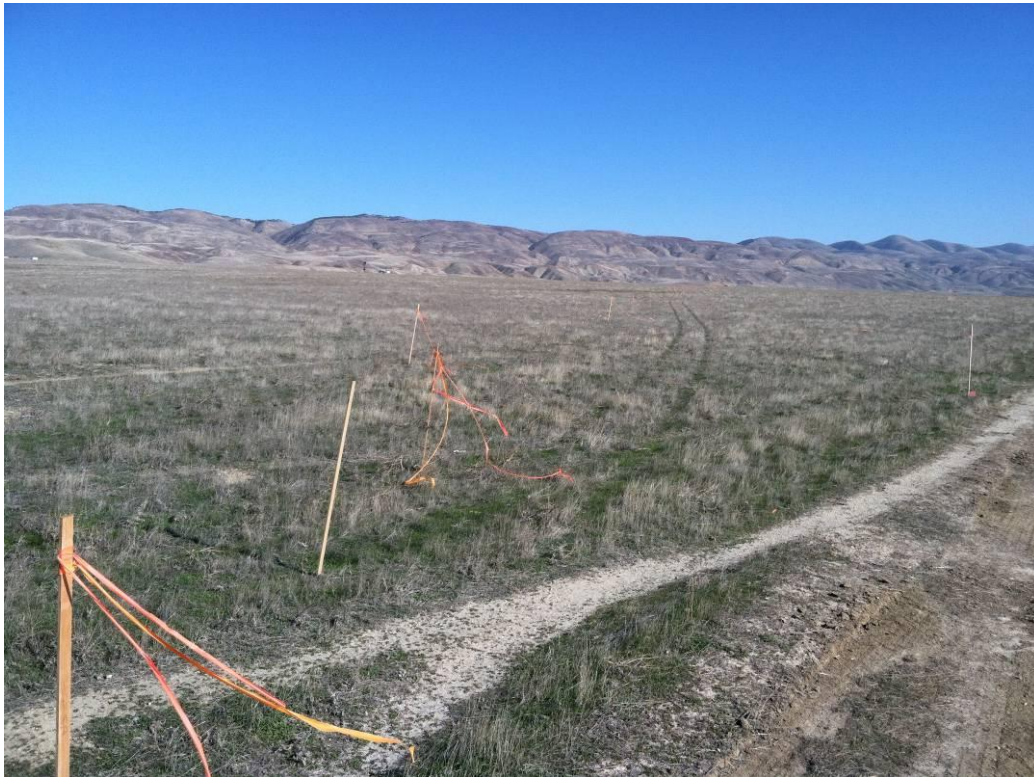
**Figure 7:** Extreme winds left the staking around the ESA Ranch Complex significantly damaged. Photograph facing north-eastward.

2. Staking for vehicle exclusion areas has been placed throughout the Project site in appropriate locations. However, much of this staking has fallen or flagging has ripped as result of weather and other wear. During the subject week, durable metal staking with strong ribbons continued to be used to replace existing wood-staking and ribbon around biological sensitive areas throughout site. However, even the new efforts were compromised by the unusual wind storms experienced on Wednesday and Thursday during the week. As a result of the winds, ribbon and staking came undone in many areas. Additionally, staking surrounding the Environmentally Sensitive Area (ESA) around the Ranch Complex has been damaged (see Figures 7 and 8). Personnel made a concerted effort to repair staking to these areas; however, more repairs are needed. **Additional improvements required according to COA #39 (biological) and #80 (cultural).**

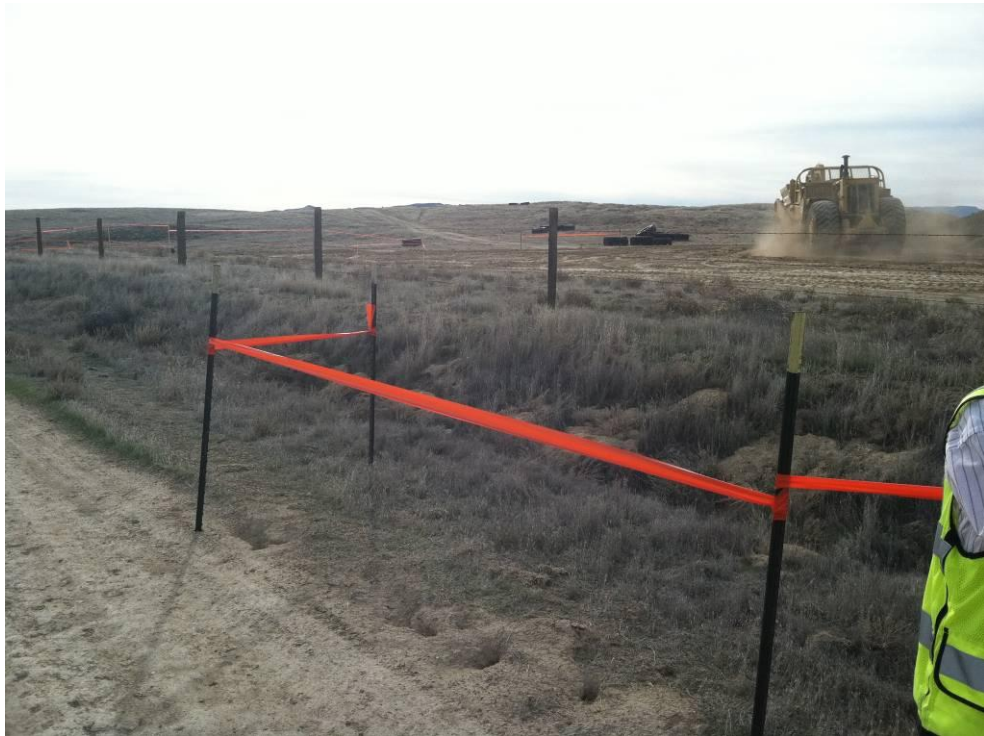
**Figures 8:** The new staking installed by the biological monitors is much more durable than previous staking measures. Photograph facing southward.

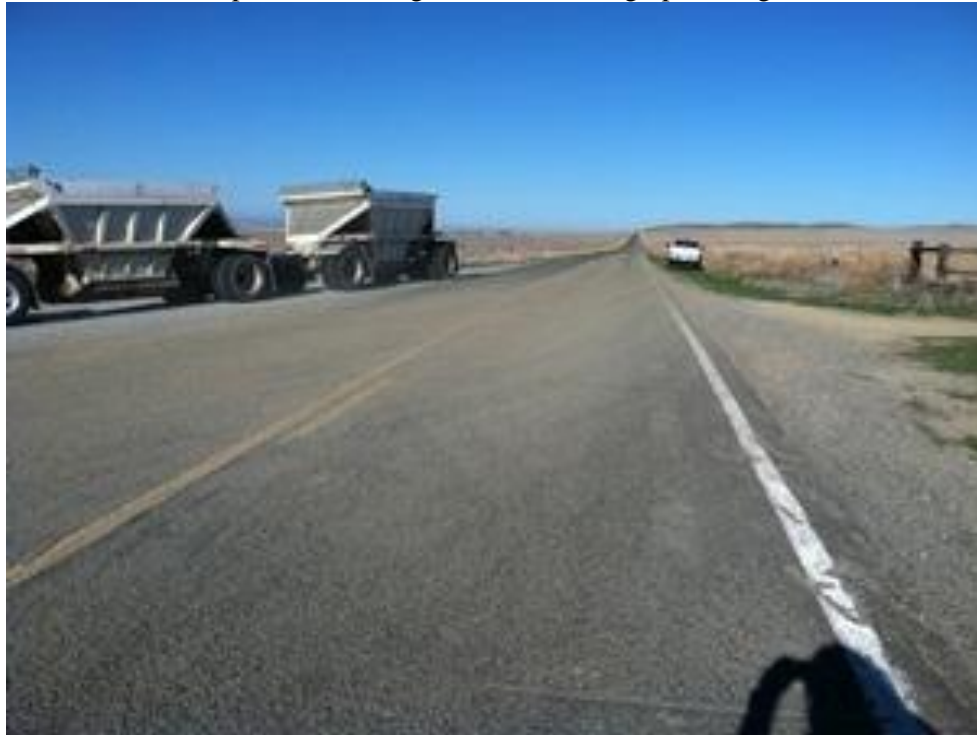
3. A road sweeper continued to operate along Highway 58 next to the project main entrance on Boulder Creek Road to clear dirt and gravel, especially during aggregate truck deliveries. However, the centerline was obscured for much of the week along Highway 58 (see Figure 9). **Additional improvements required according to Construction Activities Management Plan (CAMP) and COA 34k.**

**Figure 9:** The centerline at the project entrance (Hwy 58) remains obscured by dirt. Photograph facing westward.

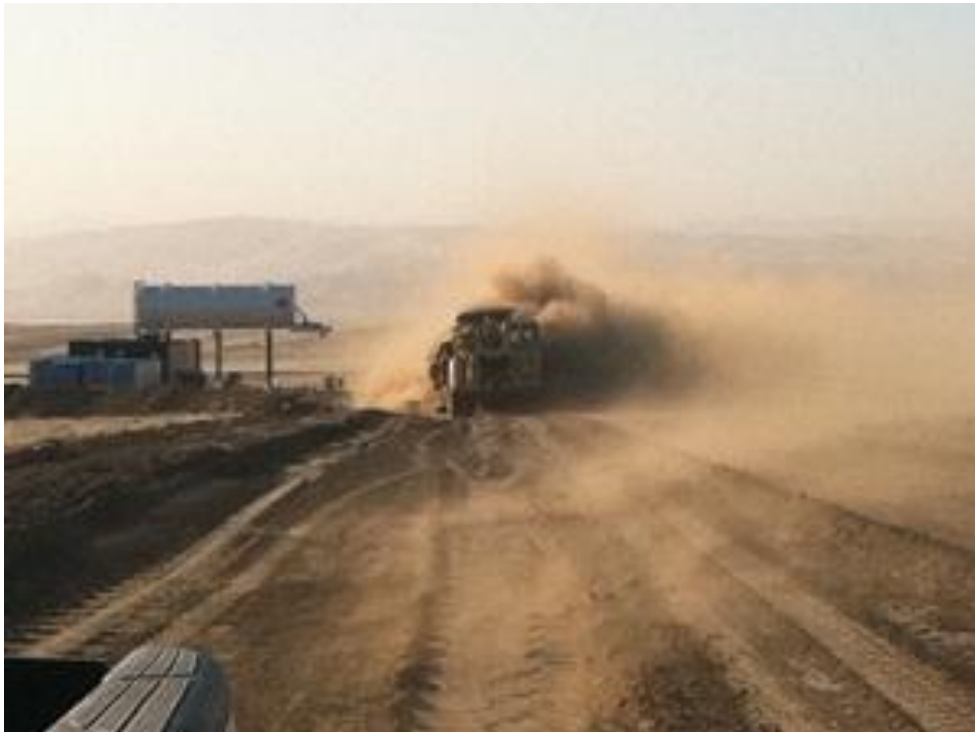
**Figure 10:** Thursday's windstorms severely exacerbated dust control issues. Photograph facing southward.

7. Dust control continued to be an issue, primarily from delivery aggregate trucks, heavy equipment and windstorms during the subject week. The primary problem is lack of water for spraying on roads and unusually excessive winds on Wednesday and Thursday of the subject week. The contractor has restricted grading and filling activities because of the limited water supply from onsite production wells (currently operating at capacity). Also, work was suspended when the wind became too great. **Additional improvements required according to COAs #33 (CAMP) and #34 to permit full construction activity as planned while preventing fugitive dust from leaving the Project site. Applicant has begun production from the second water well and is upgrading the pump at existing water well 2008-325 to increase production. Also, the continued aggregate installation along Project roads and completion of substation grading activities will passively reduce fugitive dust production.**

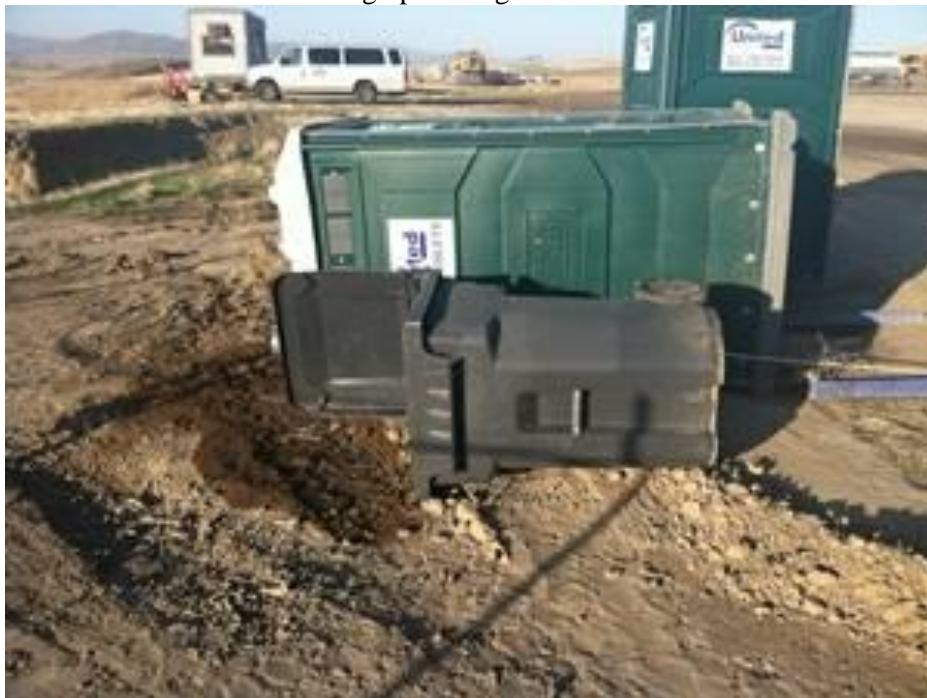
**Figure 11:** Wind overturned trashcans and portable toilets. Photograph facing westward.

18. Adequate numbers and locations of trash cans and specific labeled recycling and trash bins have been provided on site. However, the windstorm during the subject week blew over many trash cans and scattered debris. Project personnel combed large swaths of the project site locating and removing microtrash and debris. Trash receptacles were returned to needed locations and provided with improved anchoring in anticipation of future wind events. **In compliance with COA #39f (biological), COA #56(microtrash) and COA #100 (Hazardous Waste Removal #6.1).**

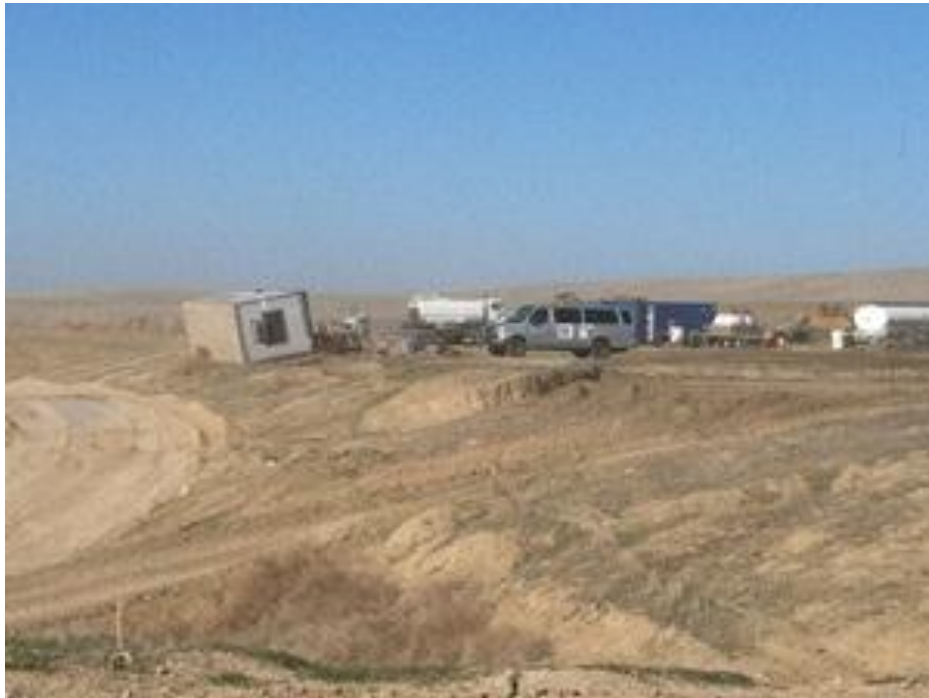
15. On Thursday, December 1, extreme wind conditions led project managers to halt all activity. Issues caused by the wind included increased fire danger, substantial fugitive dust, and damage to site facilities, including resource and Project limits staking, portable toilets, trash cans and an office trailer (see Figures 10, 11 and 12 ). On the following Friday and Saturday, work was conducted to repair and secure staking, trash, and toilets. On Saturday, an overturned trailer was recovered with the use of a crane. **In compliance with COA #34, COA #105 (Fire safety), BO pg. 15 (dust suppression).**

**Figure 12:** Strong winds overturned an office trailer. The trailer was vacant at the time. Photograph at the O&M yard facing westward.

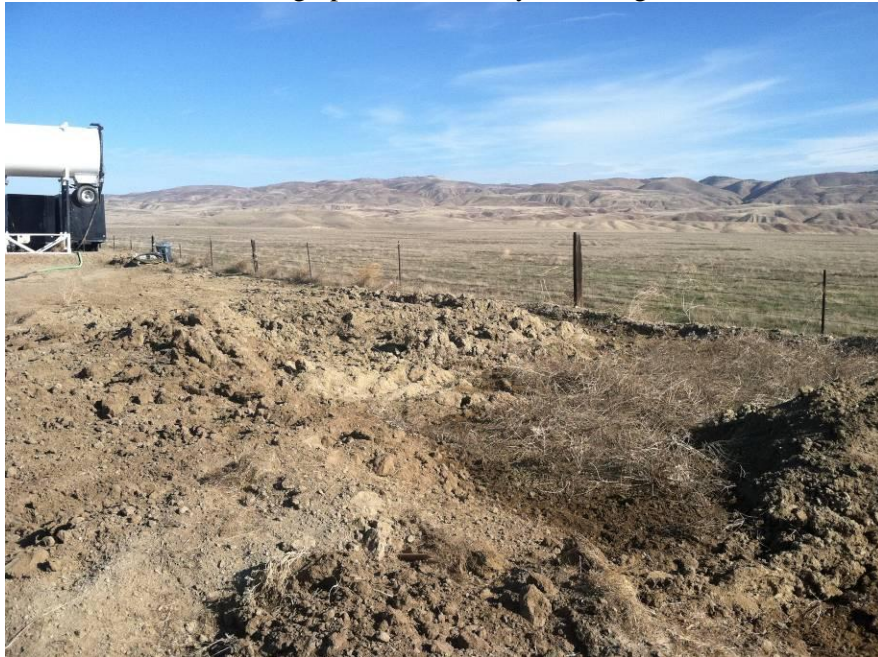
**Figure 13:** Trench and brine pond at second water well were filled in. No standing water remained. Photograph facing north-eastward.

24. There was concern that pooling water could be drawing wildlife to the project site. Tracks and scat of kit fox and birds were been observed around areas of standing water suggesting these areas were attracting more wildlife to the site. In response to these concerns, trenches containing pooling water were backfilled during the subject week (see Figure 13). Additionally fencing was installed around fuel trucks to discourage wildlife from accessing any water that gets trapped in the secondary containment system beneath it (see Figure 14).

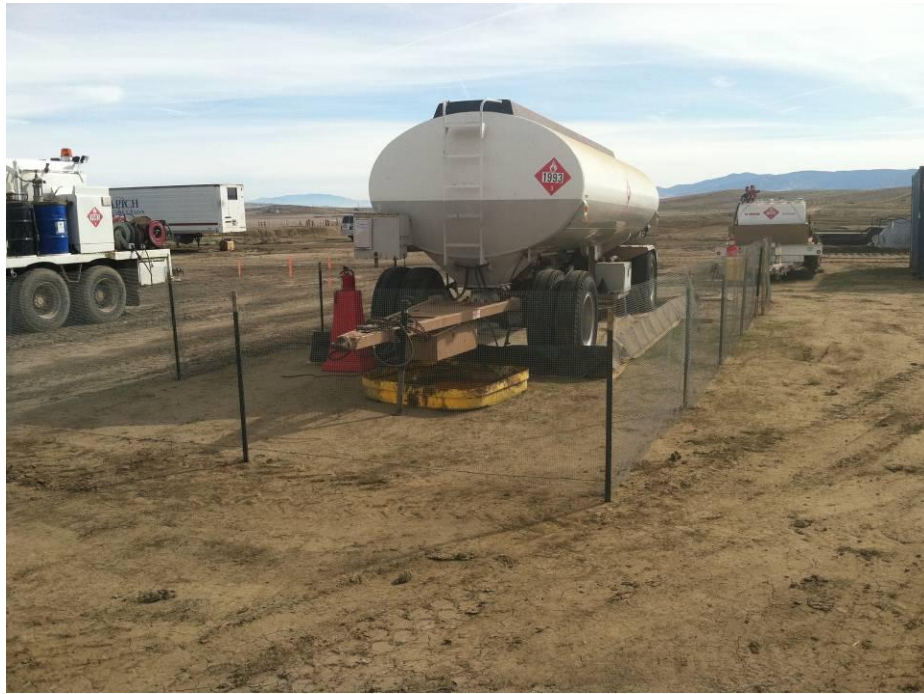
**Figure 14:** Fencing was installed around the fuel tank at the Papich staging area. Photograph facing southward.

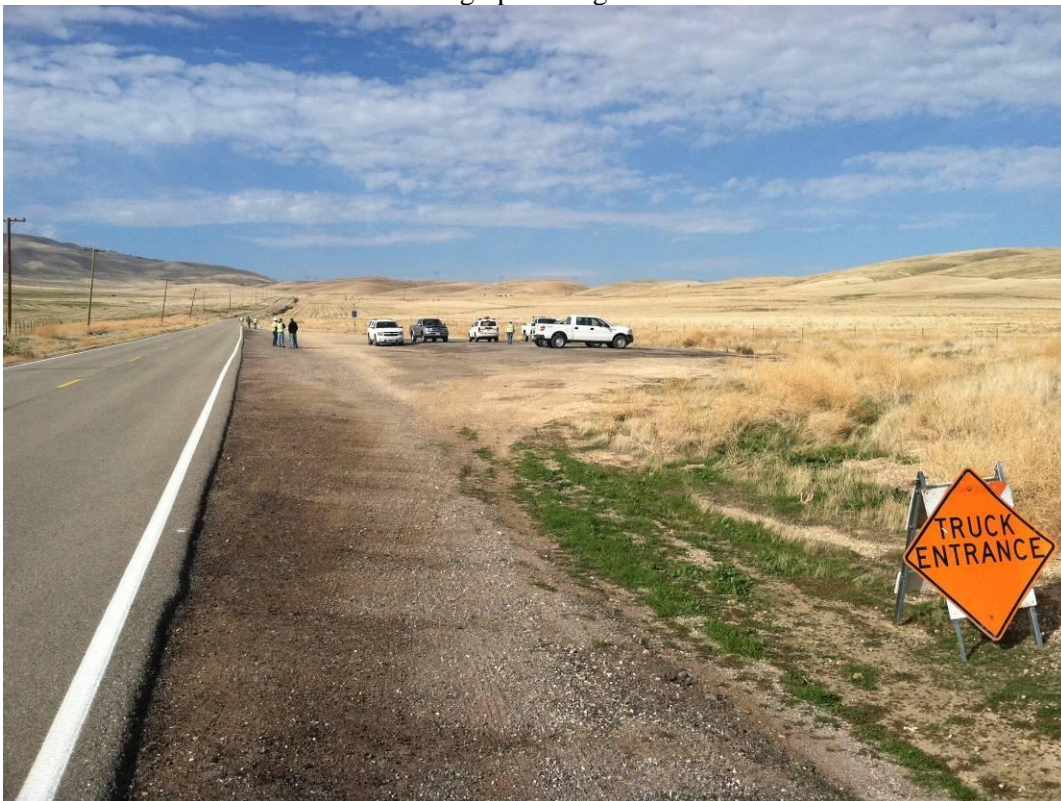
- A 12 foot strip of paving along the convoy marshalling yard (east of the site in Kern County) on Highway 58 will occur in the coming weeks to help accommodate increased traffic of project vehicle convoys (see Figure 15).

**Figure 15:** The convoy staging area east of the project, along Highway 58, will receive an additional 12' of shoulder. Photograph facing westward.
